ASIA TURBOMACHINERY & PUMP SYMPOSIUM
MARCH 2018 | SUNTEC SINGAPORE

Rotor magnetization in Turboexpander and its effect on Vibration readings

Case Study- Turboexpander in Ethylene Plant

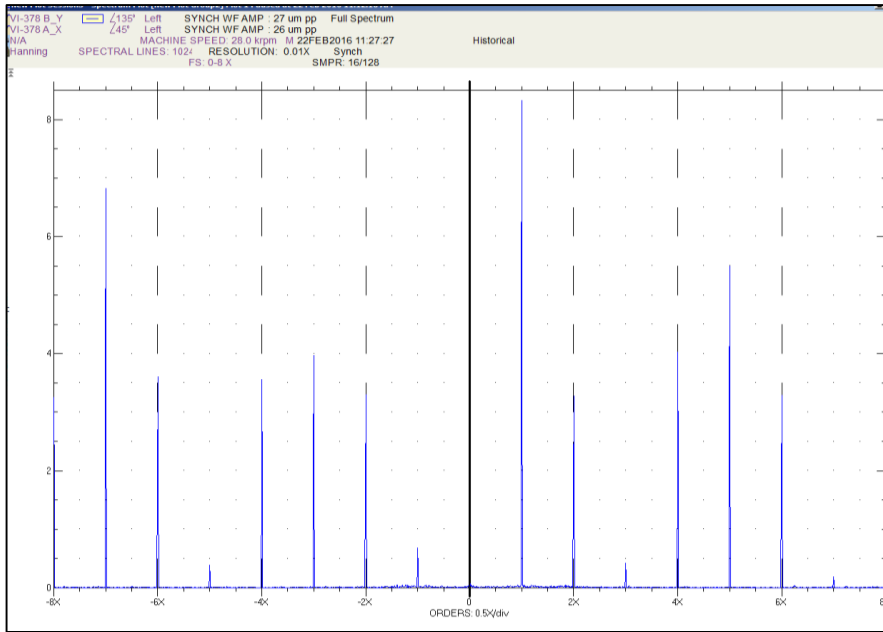
1.1 VI 378 X/Y; Full spectrum
Direct Vibration Amp 25/27 microns @25kRPM

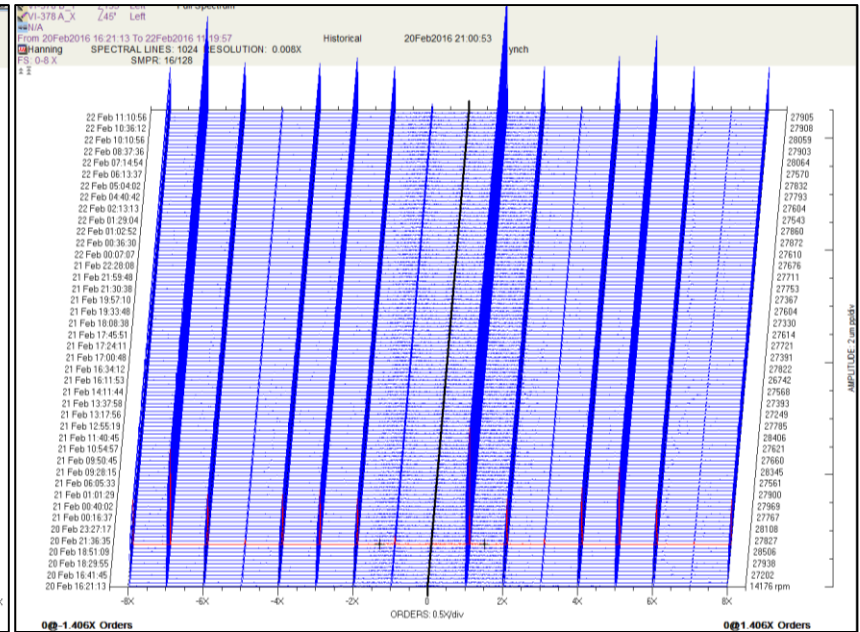
1.2 VI 378 X/Y; Waterfall diagram
Direct Vibration Amp 25/27 microns

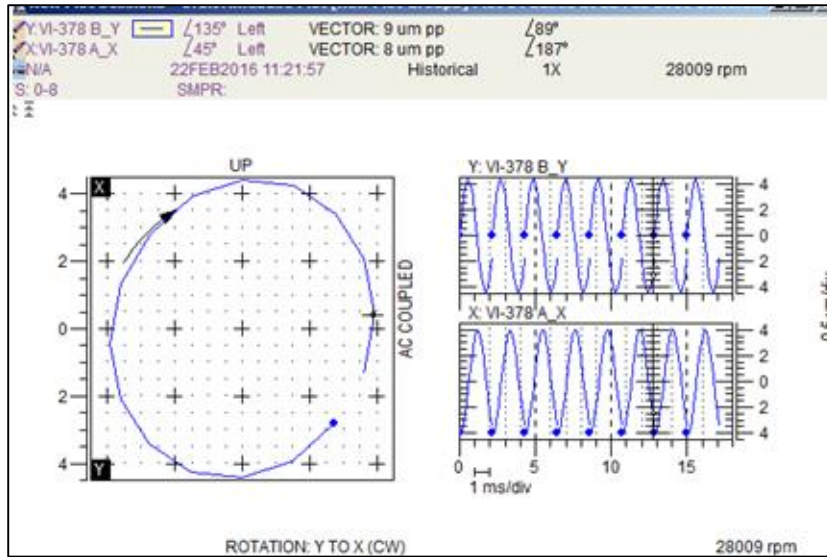
1.3 VI 378 X/Y ; Orbit Plot 1X at 28009 RPM
1X Vibration Amp 8/9 microns

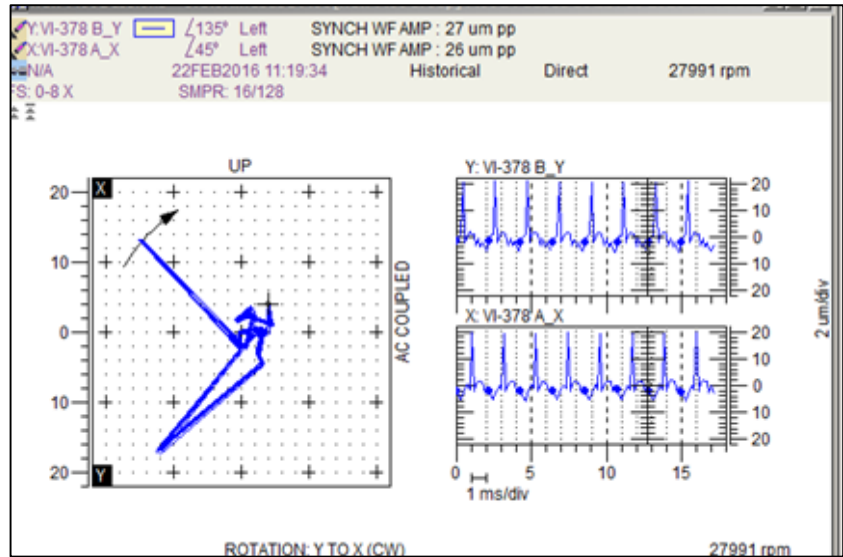
1.4 VI 378 X/Y; Orbit Plot at 27991 RPM
Direct Vibration Amp 26/27microns

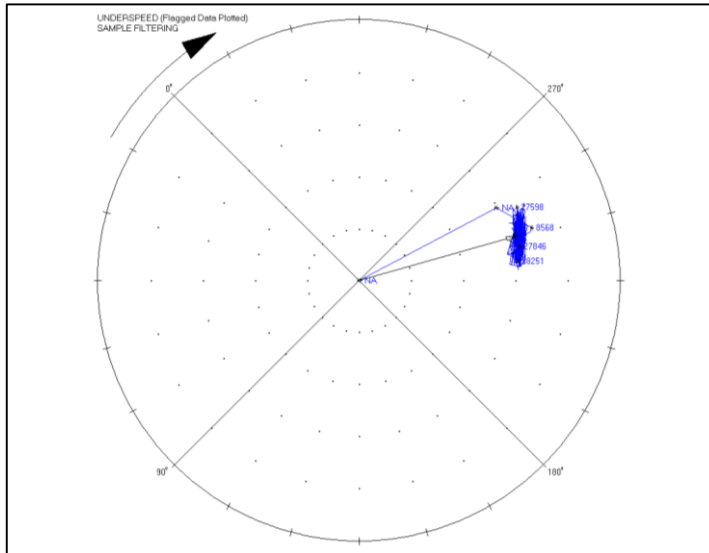
1.5 VI 378 X/Y
Polar Plot, 1X Vibration Amplitude

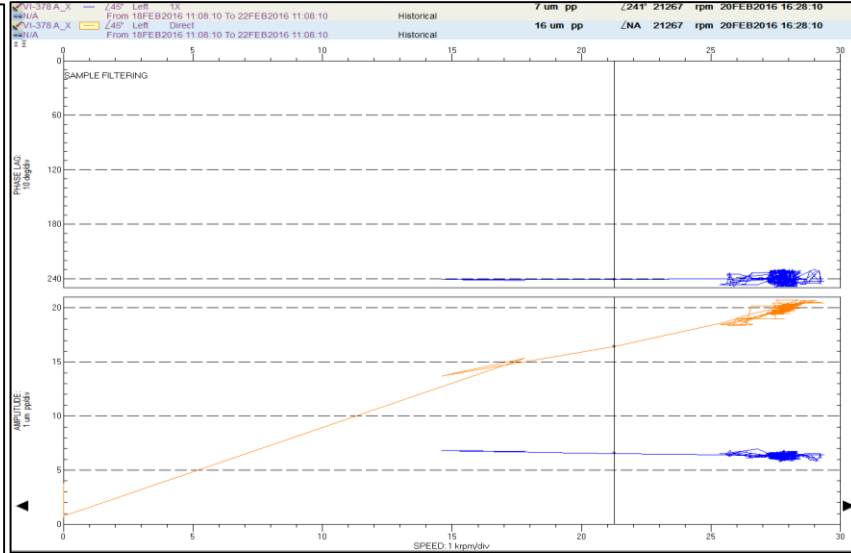
1.6 VI 378 X/Y
Bode Plot, 1X and direct Vibration Amplitude

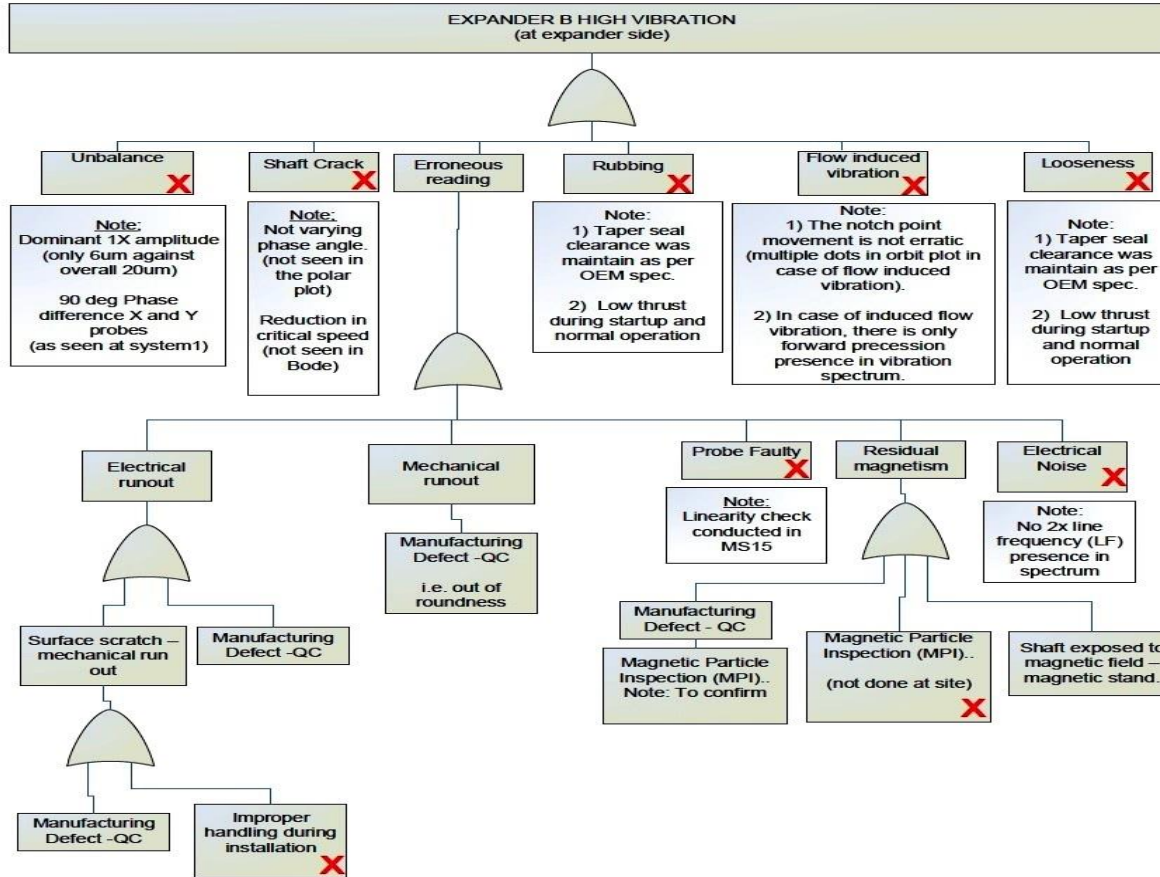
RCA- Fault Tree Analysis

- Systematic root cause analysis was done to identify and eliminate possible causes.
- Based on investigation and findings following possibilities were ruled out:-
 - Unbalance
 - Shaft crack
 - Rubbing
 - Flow induced vibration
 - Faulty vibration system
 - Mechanical Run out
- There was no record of Electrical run out of the shaft. It was decided to disassemble the unit for internal inspection.
